mid-atlantic inspection services

At your request we have performed an inspection of the property at 4608 N Park Ave in Chevy Chase, MD on August 4, 2022.

PROPERTY INSPECTION REPORT SUMMARY

Inspection Site:
4608 N Park Ave
Chevy Chase, MD 20815.

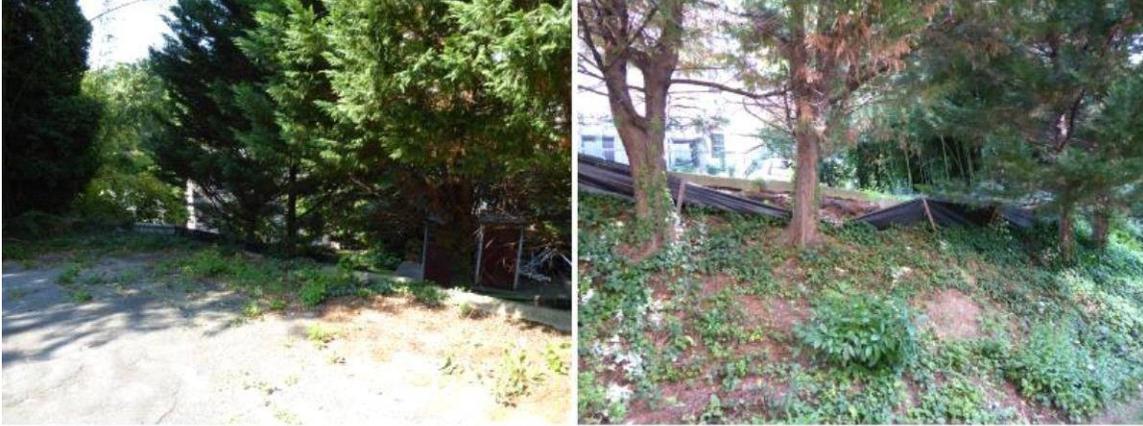
1. Stormwater management is essential to the preservation of the land and it's improvements. The adjacent property to the east has considerable impervious pavement which causes significant water flow onto the rear of the subject property. An existing temporary silt fence is no longer functional and the neighboring property' s parking lot is disintegrating and migrating down the hill. While the majority of improvements necessary for managing stormwater may rely on the neighbor, some measures must be taken to stabilize the hillside along the left rear. Grading and drainage improvements are needed as well as the establishment of a vegetative ground cover. Further evaluation and improvement is needed by a qualified landscaper.

Neighbor's lot drainage

Stormwater management is essential to the preservation of the land and its improvements. The adjacent property to the east has considerable impervious pavement which causes significant water flow onto the rear of the subject property. An existing temporary silt fence is no longer functional and the neighboring property's parking lot is disintegrating and migrating down the hill. While the majority of improvements necessary for managing stormwater may rely on the neighbor, some measures must be taken to stabilize the hillside along the left rear. Grading and drainage improvements are needed as well as the establishment of a vegetative ground cover. Further evaluation and improvement is needed by a qualified landscaper.

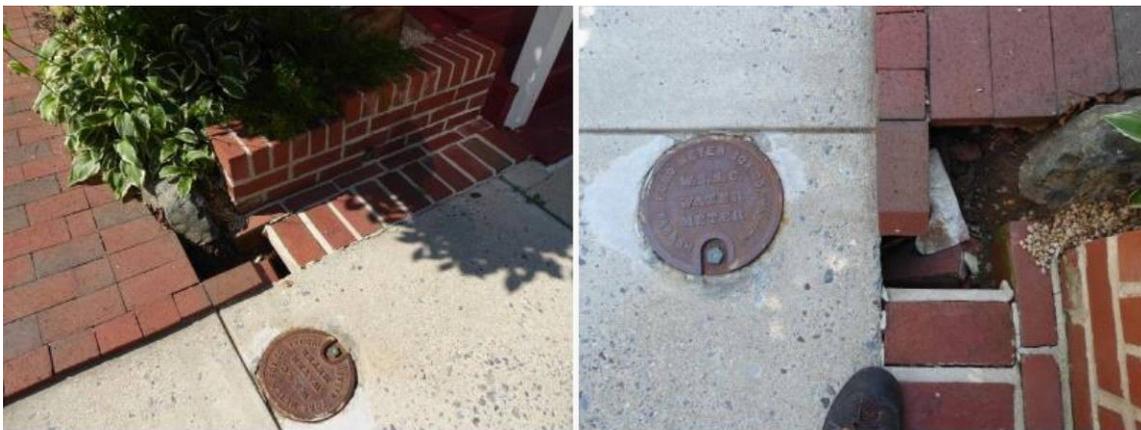
2. Stormwater drainage at the front of the property has caused a sinkhole to form around the WSSC water meter crock embedded in the sidewalk near the front stoop. This void appears to grow larger with each storm. A subterranean downspout extension is present nearby and may be a contributing factor. It may be possible to fill the void from above and redirect the flow of stormwater away from this nucleation point. The sinkhole should be filled but may necessitate a plumber and/or WSSC. I recommend that you contact the water utility and have them evaluate the meter crock located in the public right of way on North Park.

Stormwater drainage at the front of the property has caused a sinkhole to form around the WSSC water meter crock embedded in the sidewalk near the front stoop. This void appears to grow larger with each storm. A subterranean downspout extension is present nearby and may be a contributing factor. It may be possible to fill the void from above and redirect the flow of stormwater away from this nucleation point. The sinkhole should be filled but may necessitate a plumber and/or WSSC. I recommend that you contact the water utility and have them evaluate the meter crock located in the public right of way on North Park.

Sink hole at WSSC meter

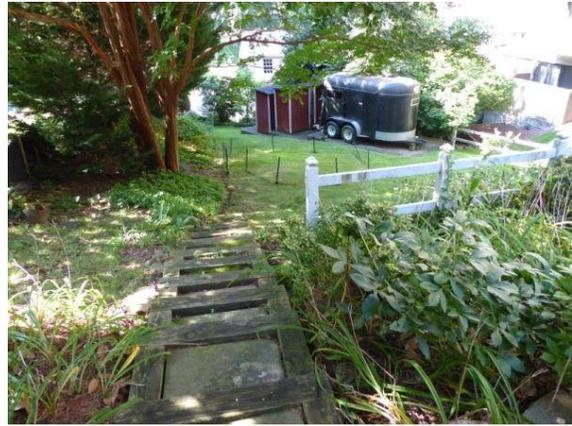
The garden stairs from the parking lot to the lower rear yard need adjustment. The timber framing is in fair condition; however, the flagstone treads have sunken creating a trip hazard. The stones should be removed and the sub base replenished and compacted. The pavers can be reset so that the full step is level and even. Further evaluation and improvement is needed by a qualified landscaper.

Garden steps are a trip hazard

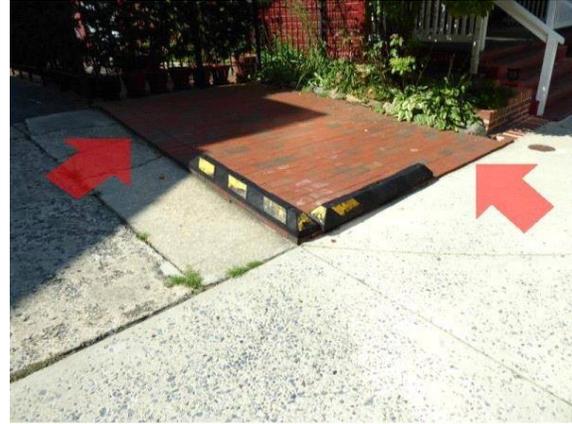
The brick patio along the left side of the structure creates a trip hazard where it meets the sidewalk. Existing trip hazard warnings are insufficient and we recommend that you remove the brick veneer pavers present between the public right of way sidewalk and the metal fencing at the front.

Brick patio creates trip hazard

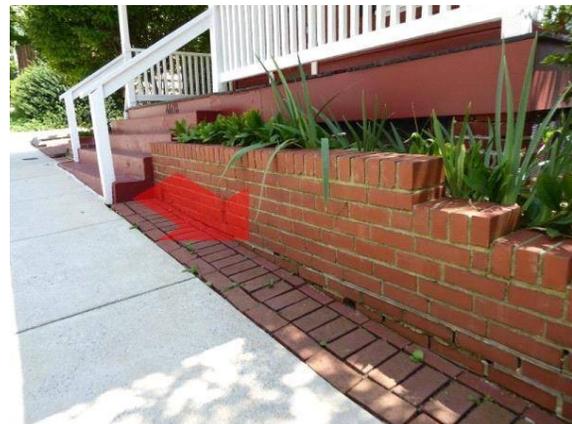
2. The brick retaining wall along the sidewalk at the front of the structure needs repair. Loose mortar joints need repointing. Drainage improvements above the wall may be needed. Deferred maintenance will result in more expensive repair costs. Further evaluation and repair is needed by a qualified mason or landscape contractor.

The brick retaining wall along the sidewalk at the front of the structure needs repair. Loose mortar joints need repointing. Drainage improvements above the wall may be needed. Deferred maintenance will result in more expensive repair costs. Further evaluation and repair is needed by a qualified mason or landscape contractor.

Front garden wall needs repointing

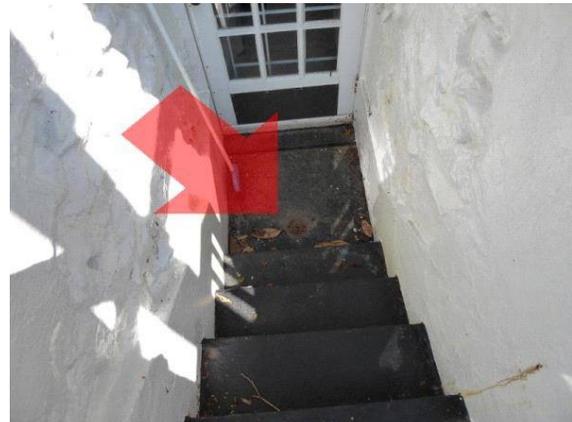
Monitor: The basement walkout floor drain should be kept clear at all times to prevent flooding.

Floor drain must be kept clear

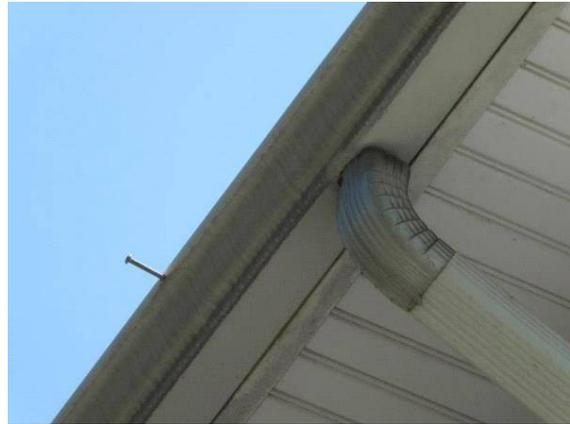
The gutter system on the roof edge appears to be functional and adequately sloped to carry the water to the downspouts. Multiple gutter nails are loose and need to be reset. The gutters should be cleaned at least seasonally. Maintenance of the gutter system is essential to storm water management and limiting moisture intrusion into the home.

Re-set gutter nails as needed

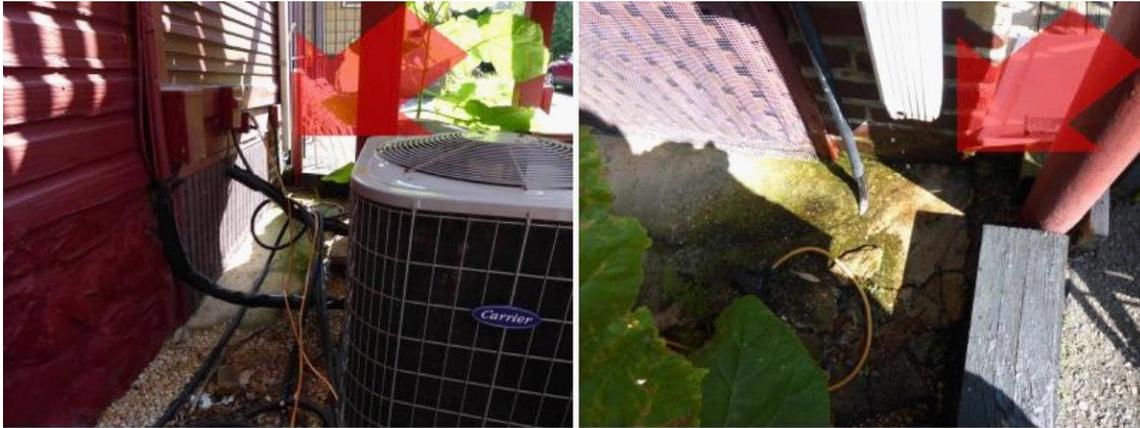
3. The downspout at the left rear corner discharges directly against the foundation. An extension is needed to route the water away from the foundation.

The downspout at the left rear corner discharges directly against the foundation. An extension is needed to route the water away from the foundation.

Downspout needs extension

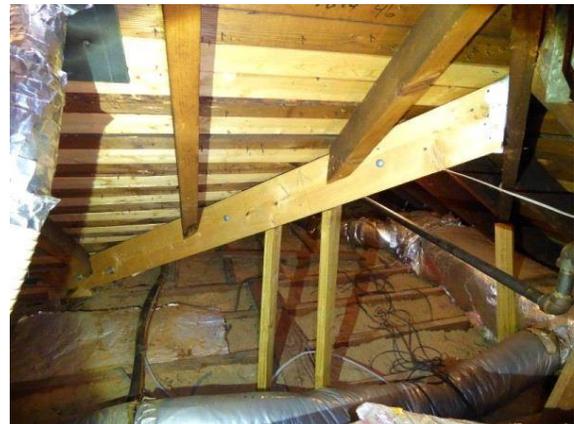
Satisfactory: The roof framing appears to be in functional condition. A structural repair is noted at the valley beam center rear. The repair appears to be professionally installed.

Repair at valley

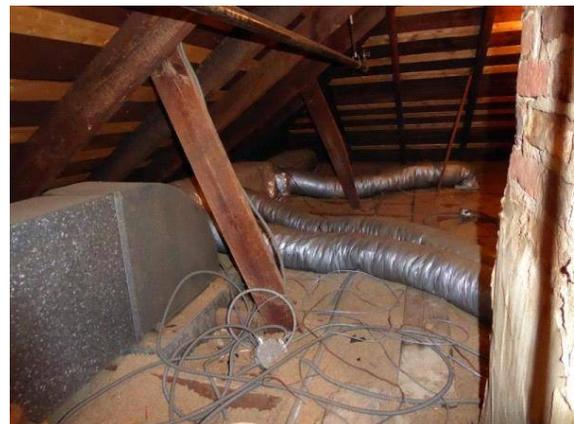
The following type of insulation was noted in the attic: Cellulose. Blown in place. The installed insulation was appropriate for the year of renovation; however, the attic insulation is inadequate by today's standards. One way to improve the overall energy efficiency of the home is air sealing and additional insulation. A blown in blanket may be the most cost effective method. Additional insulation and further evaluation is recommended by a qualified insulation contractor.

Add insulation in attic

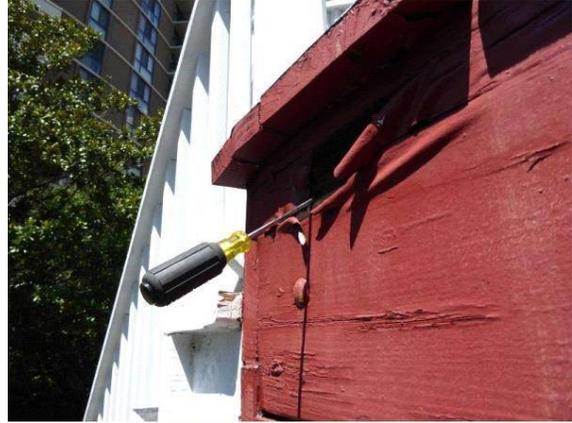
5. The stair structure at the exterior rear needs maintenance and repair. Rotted wood is present at the landing and should be replaced. Further evaluation and repair is needed by a qualified deck carpenter.

The stair structure at the exterior rear needs maintenance and repair. Rotted wood is present at the landing and should be replaced. Further evaluation and repair is needed by a qualified deck carpenter.

Wood rot noted at stair landing

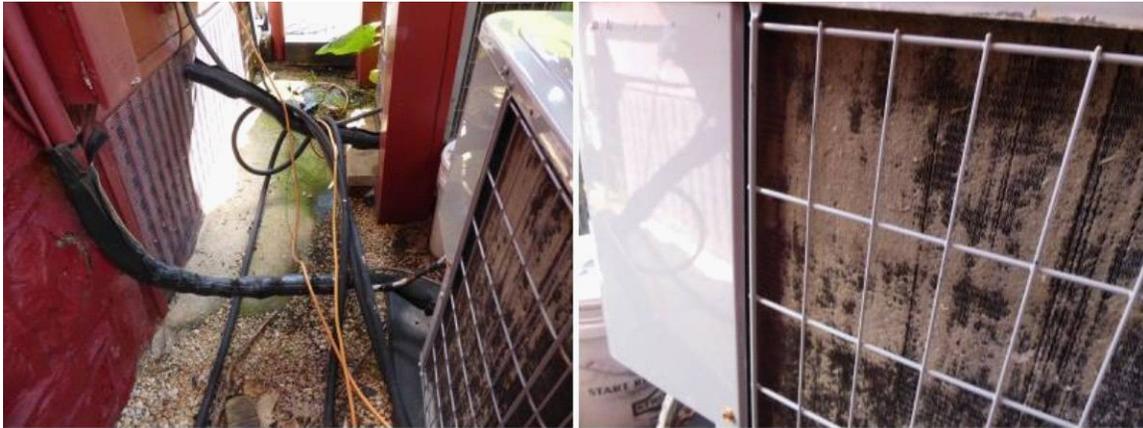
7. Repair: The exterior AC unit needs cleaning. Airborne debris that has accumulated on the heat transfer fins can affect performance and longevity. The coils need cleaning. Further evaluation is needed by a qualified HVAC technician.

Repair: The exterior AC unit needs cleaning. Airborne debris that has accumulated on the heat transfer fins can affect performance and longevity. The coils need cleaning. Further evaluation is needed by a qualified HVAC technician. <http://www.instructables.com/id/How-To-Clean-Outdoor-AC-Units/>

AC coils need cleaning

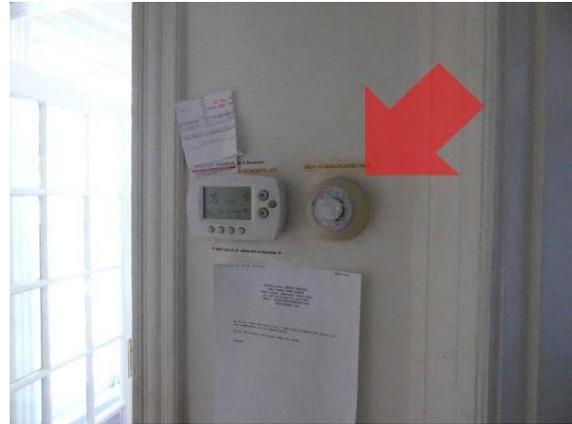
The upper level hallway thermostat controls the AC system for the, The master bedroom thermostat controls the AC system for the upper level and lower level. Initially designed as a "zoned" system, there is no longer independent control for the lower level. Cooling is supplied and controlled by the upper level/attic AC system. The dial "heat" thermostat in the upper level is no longer functional and does not control the heat for the upper level. Heating for the upper level is controlled by the main level thermostat.

Dial thermostat no longer functional

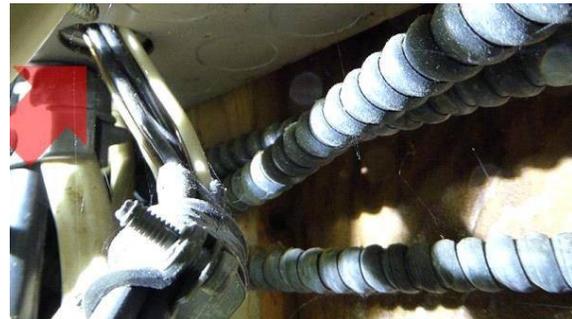
11. Repair: The electric service panel cover only has 3 of 4 cover screws. All 4 should be installed. Panel covers are required to be secured with blunt tipped screws to prevent damage to the internal wiring and prevent shocks. There are missing bushings where wires pass through the bottom of the panel enclosure. Further evaluation and repair is needed by a qualified electrician.

Repair: The electric service panel cover only has 3 of 4 cover screws. All 4 should be installed. Panel covers are required to be secured with blunt tipped screws to prevent damage to the internal wiring and prevent shocks. There are missing bushings where wires pass through the bottom of the panel enclosure. Further evaluation and repair is needed by a qualified electrician.

Loose bushing

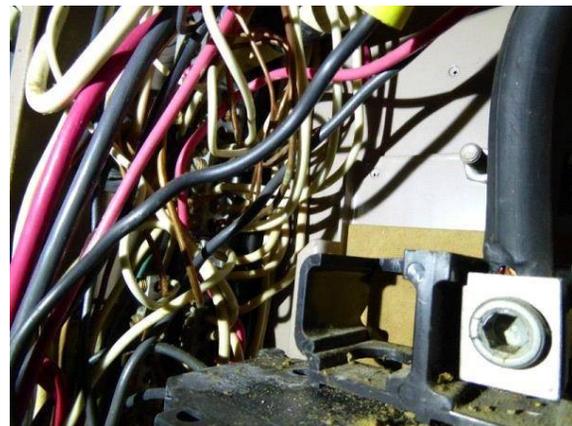
The neutral is only bonded to ground at the service equipment which is the disconnect located next to the panel. At all other points throughout the house, there should be no connection between the bare (or green) grounding conductor and the white neutral conductor. Under normal conditions, the grounding conductor carries no current. No current means there is no voltage drop along it, therefore anything "grounded" to this conductor is at the same potential (voltage) as ground. If the neutral and ground are bonded at the sub panel, then stray currents from the neutral return could go thru the equipment ground on the electrical devices fed from this sub panel. The service equipment panel is where the neutral and equipment ground should be bonded and services of a qualified electrician are needed to correct the wiring in this panel.

This panel has the neutral (white) wires and the ground (bare copper) bonded to the same bus. The neutral is only bonded to ground at the service equipment which is the disconnect located next to the panel. At all other points throughout the house, there should be no connection between the bare (or green) grounding conductor and the white neutral conductor. Under normal conditions, the grounding conductor carries no current. No current means there is no voltage drop along it, therefore anything "grounded" to this conductor is at the same potential (voltage) as ground. If the neutral and ground are bonded at the sub panel, then stray currents from the neutral return could go thru the equipment ground on the electrical devices fed from this sub panel. The service equipment panel is where the neutral and equipment ground should be bonded and services of a qualified electrician are needed to correct the wiring in this panel.

Ground and neutral wires to be separated

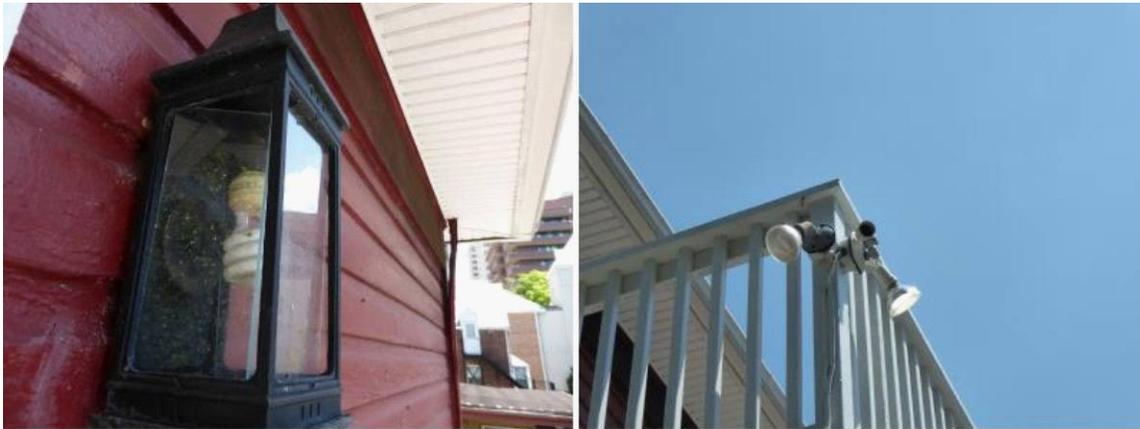
14. The exterior security lighting consists of multiple floodlights. Several fixtures are missing one or more bulbs. We recommend that you replace all of the exterior security lighting with LED fixtures. Further evaluation and repair is needed by a qualified electrician.

The exterior security lighting consists of multiple floodlights. Several fixtures are missing one or more bulbs. We recommend that you replace all of the exterior security lighting with LED fixtures. Further evaluation and repair is needed by a qualified electrician.

Replace with new fixtures

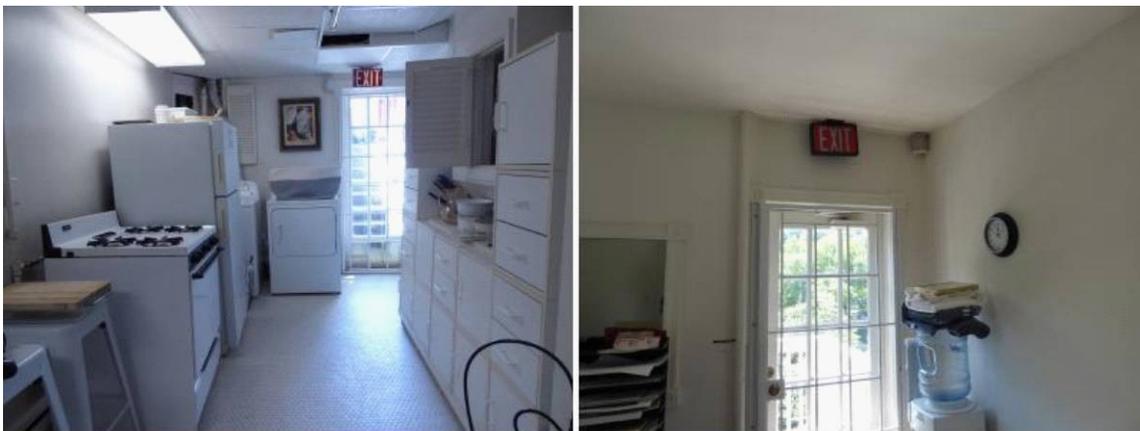
Emergency exit signage and lighting are nonfunctional and nonconforming to current safety requirements for a mixed-use building. We recommend that these fixtures be replaced with conforming units. Further evaluation and repair is needed by a qualified electrician.

Emergency lighting not functional

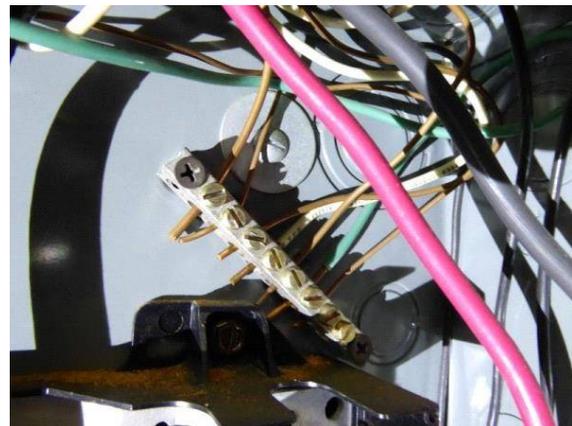
15. Further Evaluation: The sub-panel has the neutral (white) wires and the ground (bare copper) bonded to the same bus. The neutral is only bonded to ground at the service panel. At all other points throughout the house there should be no connection between the bare (or green) grounding conductor and the white neutral conductor. Under normal conditions, the grounding conductor carries no current. No current means there is no voltage drop along it, therefore anything "grounded" to this conductor is at the same potential (voltage) as ground. If you bond the neutral and ground at the sub panel, then stray currents from the neutral return could go through the equipment ground on the electrical devices fed from this sub panel. The main panel is where the neutral and equipment ground should be bonded and services of a qualified electrician are needed to correct the wiring in this panel.

Further Evaluation: The sub-panel has the neutral (white) wires and the ground (bare copper) bonded to the same bus. The neutral is only bonded to ground at the service panel. At all other points throughout the house there should be no connection between the bare (or green) grounding conductor and the white neutral conductor. Under normal conditions, the grounding conductor carries no current. No current means there is no voltage drop along it, therefore anything "grounded" to this conductor is at the same potential (voltage) as ground. If you bond the neutral and ground at the sub panel, then stray currents from the neutral return could go through the equipment ground on the electrical devices fed from this sub panel. The main panel is where the neutral and equipment ground should be bonded and services of a qualified electrician are needed to correct the wiring in this panel.

Grounds and neutrals to be separated

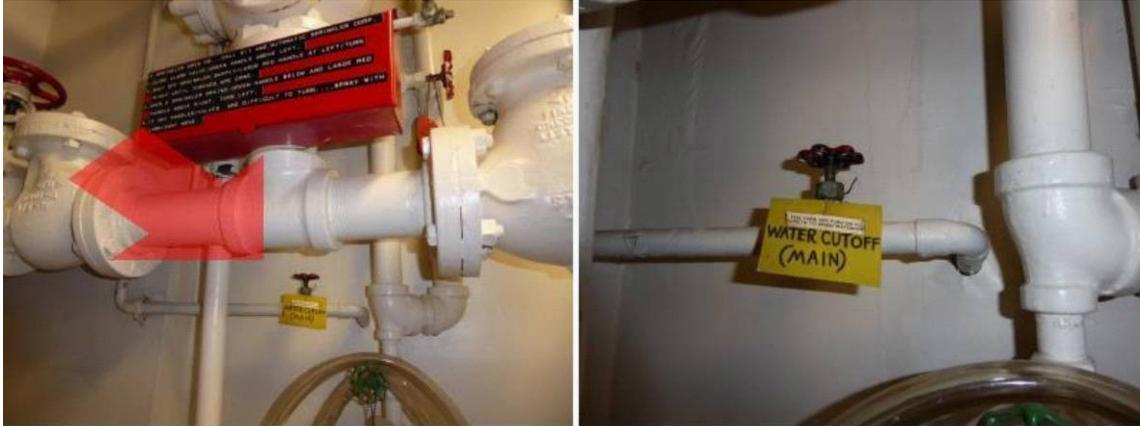
The main water shut off valve is located at the basement level left side wall in the utility room. The main valve was not operated. The installed gate valve is an older style and our experience has taught us that these valves that are not routinely operated can leak when the valve handle is turned. Replacement with a ball valve is recommended.

Main water valve

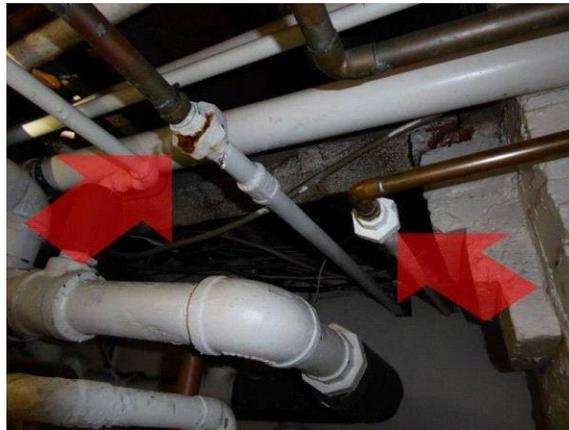
Future renovations may necessitate replace

The interior supply piping in the structure is predominantly copper. There is also some older galvanized piping installed. Galvanized steel (iron) piping was common until roughly 1950. This piping typically lasts 40 to 60 years. Some lower-quality pipes do not last as long and there are some oversized pipes still in use after 60 years. Where it is found today in single-family homes, it is usually near the end of its life. "Galvanized" refers to a metal plating process that coated iron or steel water pipe surfaces with a corrosion-resistant zinc surface. Galvanized steel supply pipes are typically 3/4 to 1/2-inch in diameter. The connections are threaded. When the pipe corrodes, the rust accumulation inside the pipe chokes down the diameter of the pipe, resulting in poor water pressure. Over time, the rough walls of the galvanized piping collect mineral deposits from the water. As this accumulation grows, it reduces the interior water flow. Eventually, the flow is so restricted that replacement is needed.

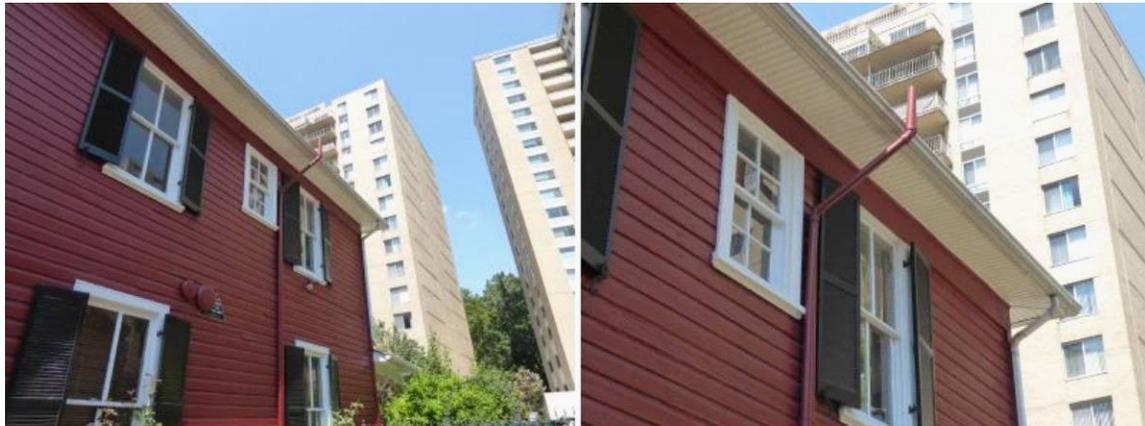
21. PVC wastewater pipe vents are installed on the exterior at the left side of the structure. These pipes are necessary for the functioning of the lower level plumbing but are inadequately supported along the side wall and roof edge. Additional pipe strapping four hangers are needed. Further evaluation and repair is needed by a qualified plumber.

PVC wastewater pipe vents are installed on the exterior at the left side of the structure. These pipes are necessary for the functioning of the lower level plumbing but are inadequately supported along the side wall and roof edge. Additional pipe strapping four hangers are needed. Further evaluation and repair is needed by a qualified plumber.

Add pipe hangers as needed

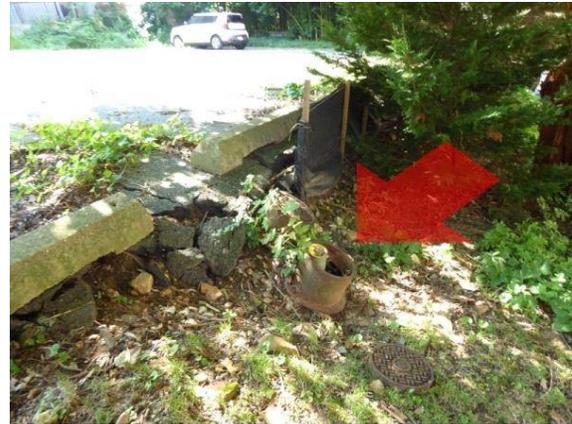
23. There are two WSSC sewer cleanouts present in the rear yard near the adjoining parking lot. Cast iron covers are present but improperly installed. Degradation and migration of the neighboring parking lot may cause damage to the subterranean piping and lead to sewage blockages. The cleanout elevation should be adjusted as needed and the piping protected. Further evaluation and repair is needed by a qualified plumber.

There are two WSSC sewer cleanouts present in the rear yard near the adjoining parking lot. Cast iron covers are present but improperly installed. Degradation and migration of the neighboring parking lot may cause damage to the subterranean piping and lead to sewage blockages. The cleanout elevation should be adjusted as needed and the piping protected. Further evaluation and repair is needed by a qualified plumber.

Cleanouts in rear yard

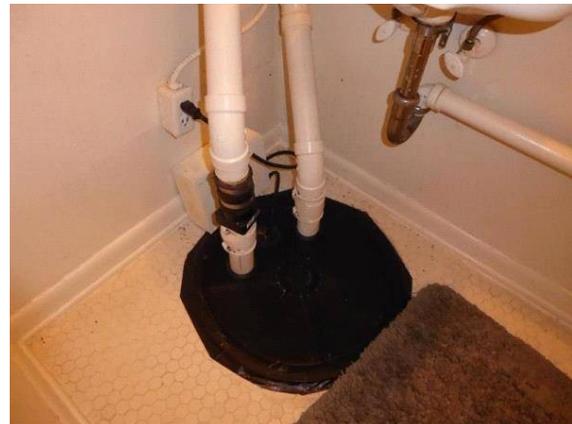
There is a sewage pump installed. This is needed either because of the elevation of the lowest fixture in relation to the sewer line or because of the distance to the sewage main. This unit requires periodic maintenance. The pump functioned normally at the time of the inspection. The sewage pump cover is not sealed. Sewer gas may be present in the home. The cover should be properly sealed. Further evaluation and repair is needed by a qualified plumber.

Sewage ejector in lower level bath

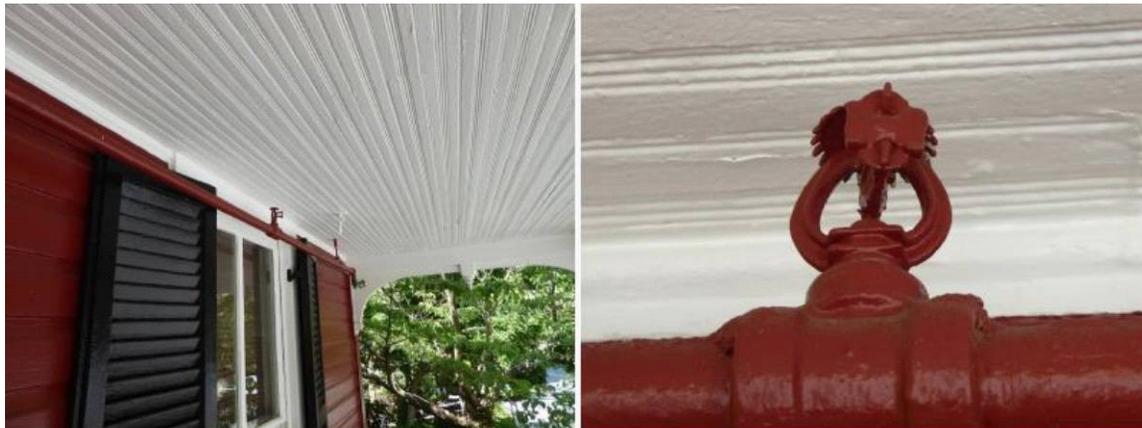
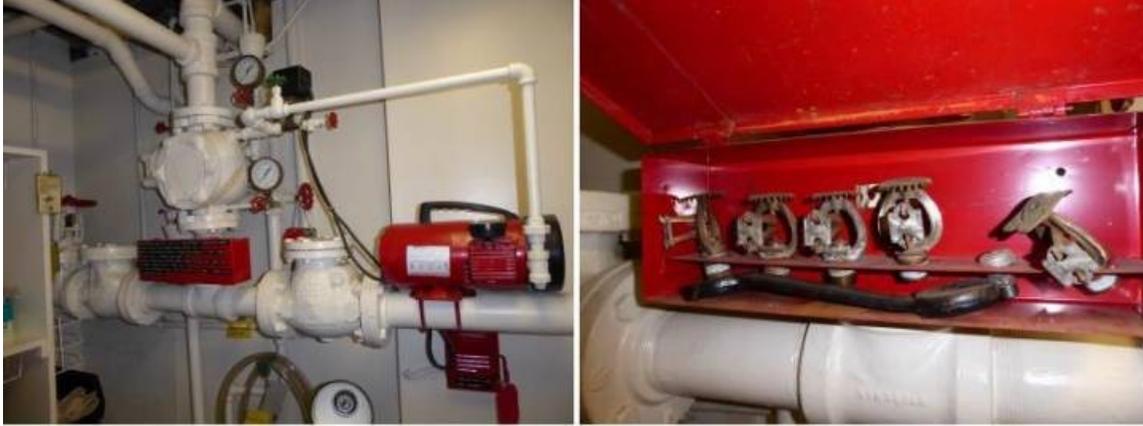
4. The fire suppression system is not functional. The main water supply valve for this system is in the closed position and there is no pressure indicated on the air and water gauges. Multiple sprinkler heads on the front porch have been painted and may not function as intended. Spare/replacement sprinkler heads are present in the lower level utility room next to the fire suppression system control and valve. It appears this system was installed during the last major renovation in approximately 1988. This system needs to be serviced and may need to be upgraded so that it conforms to current mixed-use requirements. Further evaluation and repair is needed by a qualified plumber or sprinkler technician.

The fire suppression system is not functional. The main water supply valve for this system is in the closed position and there is no pressure indicated on the air and water gauges. Multiple sprinkler heads on the front porch have been painted and may not function as intended. Spare/replacement sprinkler heads are present in the lower level utility room next to the fire suppression system control and valve. It appears this system was installed during the last major renovation in approximately 1988. This system needs to be serviced and may need to be upgraded so that it conforms to current mixed-use requirements. Further evaluation and repair is needed by a qualified plumber or sprinkler technician.

Fire supression system not functional

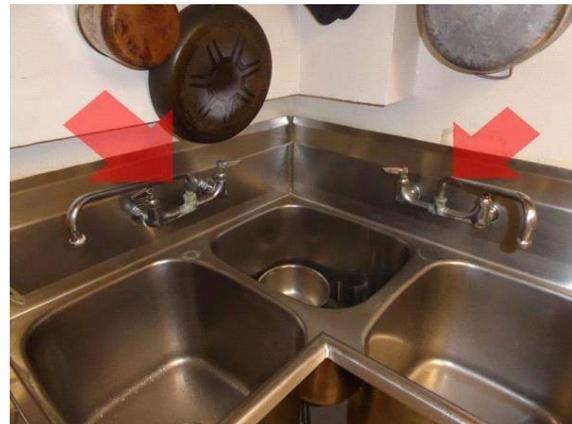
26. Repair: The lower level kitchen faucets leak at the goose necks. Further evaluation and repair is needed by a qualified plumber.

Repair: The lower level kitchen faucets leak at the goose necks. Further evaluation and repair is needed by a qualified plumber.

Faucets leak at spouts

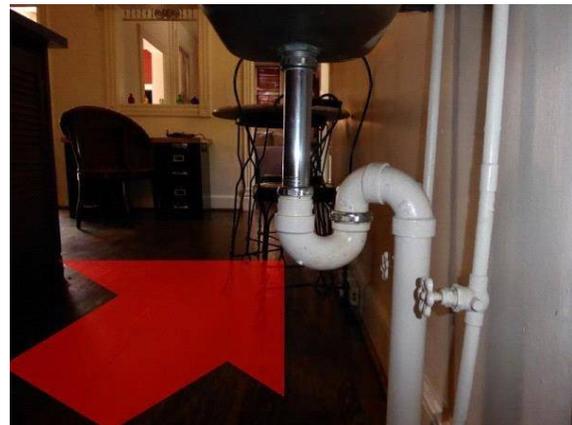
The wet bar sink waste water trap is not properly vented. The installed "S" trap should be replaced. Further evaluation and repair is needed by a qualified plumber.

Replace "S" trap

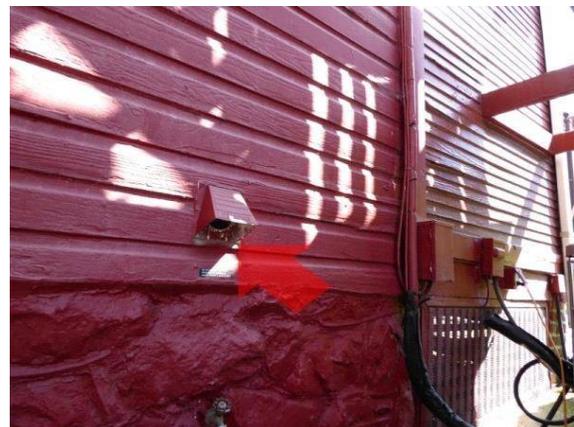
Dryer vent damper is missing

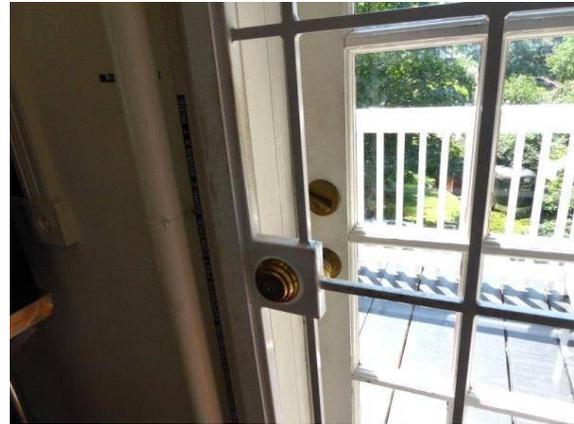
<https://www.angieslist.com/articles/are-double-keyed-deadbolt-locks-safe.htm>.

Keyed interior locks are a safety hazard
