# VILLAGE OF FRIENDSHIP HEIGHTS INFRASTRUCTURE ASSESSMENT

AMT File No. 22-0124.001

**A. Morton Thomas and Associates, Inc.**

**August 2, 2022**

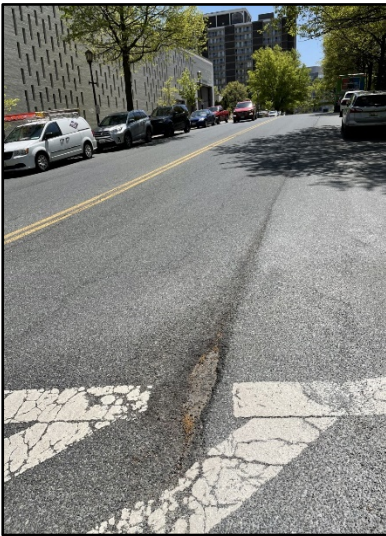
**The Hills Plaza**

**Longitudinal Cracking**

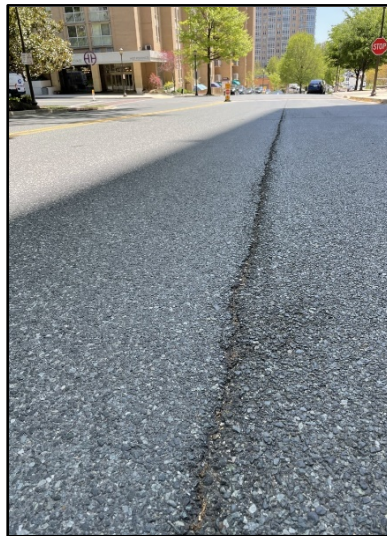
**Friendship Boulevard**

4.	Friendship Boulevard	Willard Avenue to South Park Avenue		X			<b>Good-Satisfactory</b>	Some light longitudinal cracking
5.	Friendship Boulevard	South Park Avenue to Somerset Terrace	X	X	X		<b>Fair-Poor</b>	Moderate to severe longitudinal cracking along entire roadway.

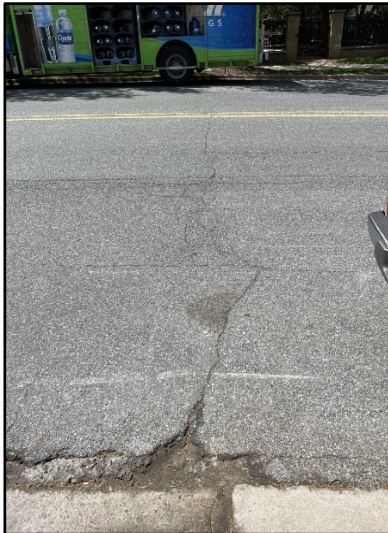
**The Hills Plaza**

### Transverse Cracking

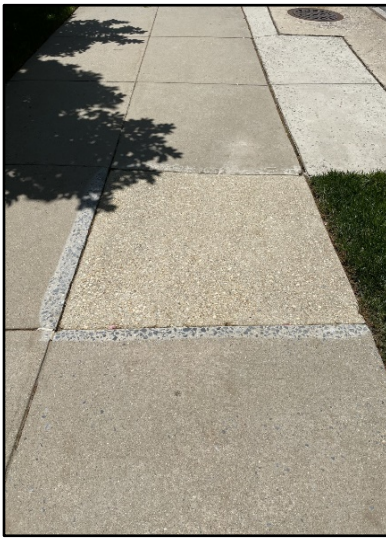
4550 North Park Avenue

Sidewalks within the Village's right-of-way are in good condition. They are well maintained with no tripping hazards observed. The curb and gutters are in good to fair condition with few replacements required. Curb upheaval from tree roots was minimal. Several curbs/aprons adjacent to buildings require attention. In addition to the locations in the photographs below, 5498 Shoemaker Farm Lane, 4604 North Park Avenue (garage), 5550 Friendship Boulevard (both entrances), Chase Tower parking entrance, 5559 The Hills Plaza and Highland House garage entrance on The Hills Plaza are noted for repair.

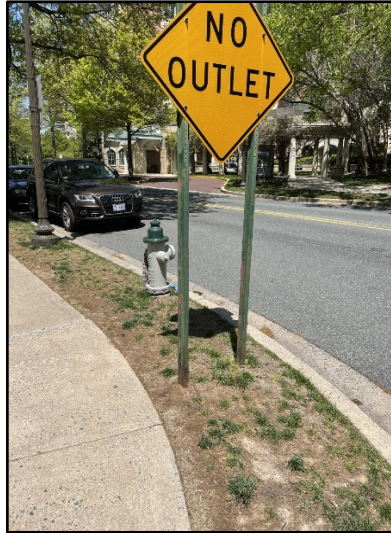
Friendship Boulevard at  
North Park Avenue

Traffic signs are in good condition. However, several signposts require repainting or vertical realignment. Pavement markings are in fair condition with some damage due to pavement cracking.

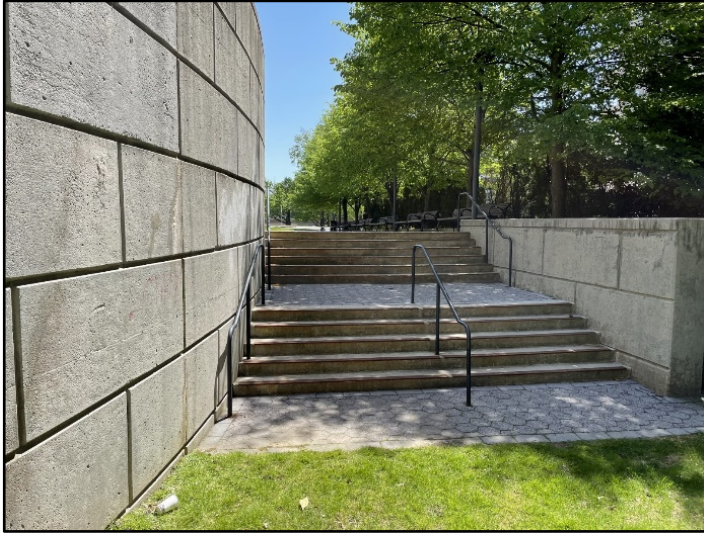
The park was renovated in 2001. The pavement, sidewalks, steps and benches are currently in good condition. Two maintenance issues were observed. A central handrail was missing from one flight of steps and the railings need to be painted.

**Missing Central Railing**

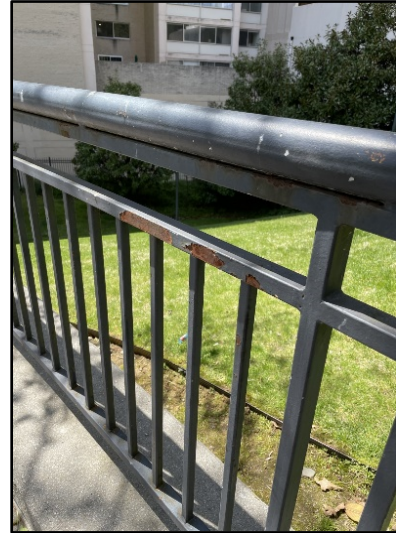
**Repaint Railing**

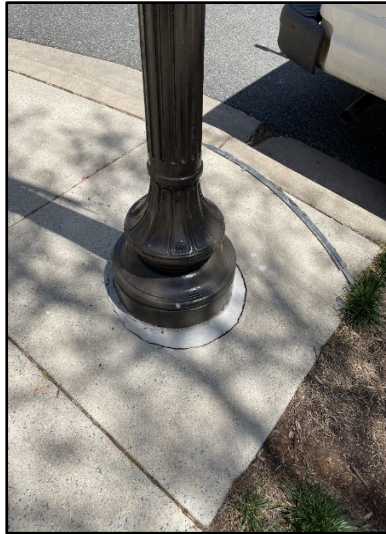
**Shoemaker Farm Lane at  
North Park Avenue**

The streetlights are in good condition, having recently being painted with all bases sealed. One light fixture at the intersection of Shoemaker Farm Lane and North Park Avenue appeared to be loosely attached to the post. The site visits for this study were conducted during daylight hours so the lights were not operational.
