mid-atlantic inspection services

At your request we have performed an inspection of the property at 4608 N Park Ave in Chevy Chase, MD on August 4, 2022.

PROPERTY INSPECTION REPORT SUMMARY

Inspection Site:
4608 N Park Ave
Chevy Chase, MD 20815.

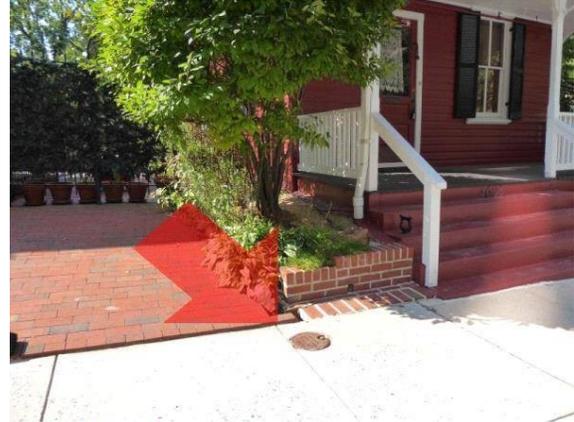
The water meter is located in the side walk several feet in from the street. The water meter(s) is equipped with a remote sensor. Meter reading happens from outside the structure. When taking ownership of the property you will need to transfer the water service.

WSSC water meter

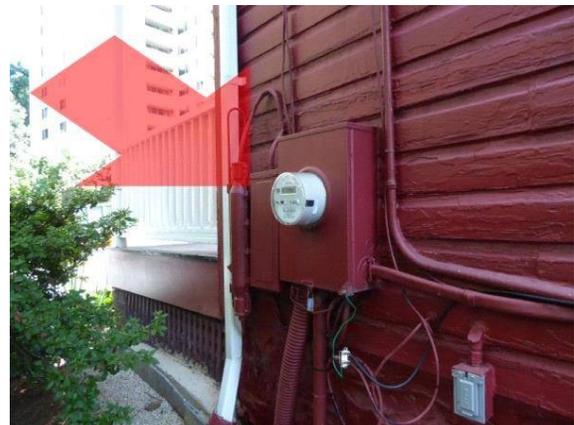
The electric service is provided underground from the utility. The electric service meter is located at the right side exterior. The meter is equipped with a remote sensor and is read from outside the structure. When taking ownership of the property you will need to transfer the electric service.

Pepco Meter

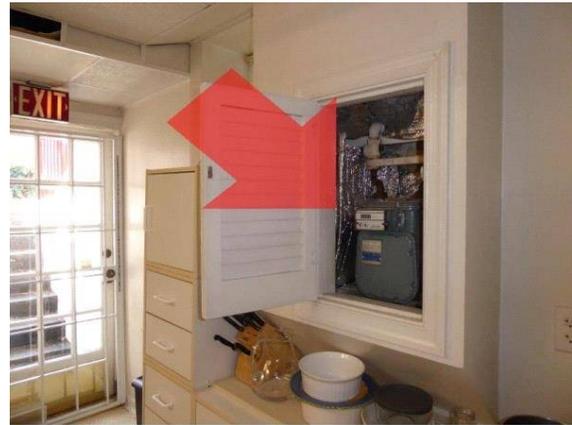
The gas meter and main gas valve are located in the basement at the right side rear wall. The gas meter is equipped with a remote sensor. Meter reading happens from outside the structure. When transferring ownership of the property you will need to transfer the gas service.

Washington Gas meter

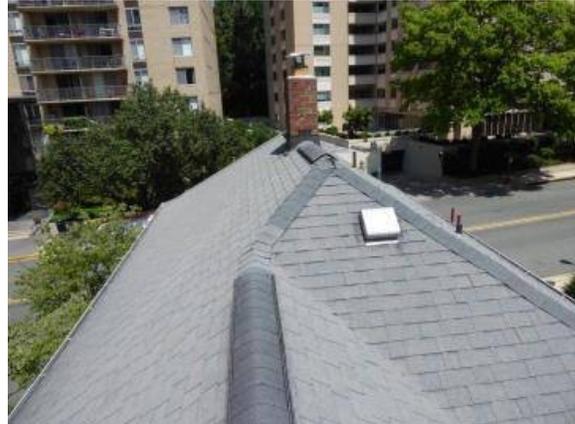
Satisfactory: The roof covering material is in a condition that is consistent with its age and method of installation; showing no deficiency or cause for immediate concern. Periodic maintenance is needed. You should visually inspect the roof at least seasonally.

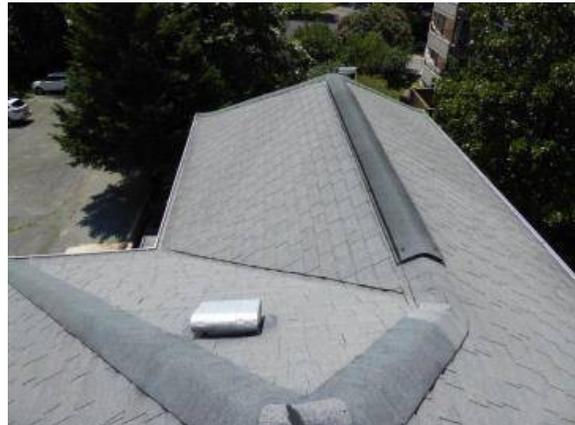
The roof covering material appears to have a remaining life expectancy of 5 to 10 years, assuming proper maintenance is completed as needed. The life expectancy given is the best estimate of the inspector, assuming proper maintenance. The actual life of the roofing materials used can be influenced by external sources like weather extremes, conditions caused by trees and vegetation, and mechanical damage.

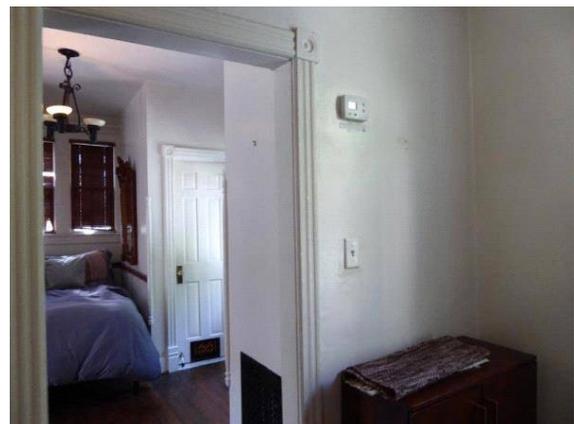
The main level hallway thermostat controls the AC system for the main level only. This thermostat also controls the heat for the main and upper levels.

Main floor AC and heat for main/upper level

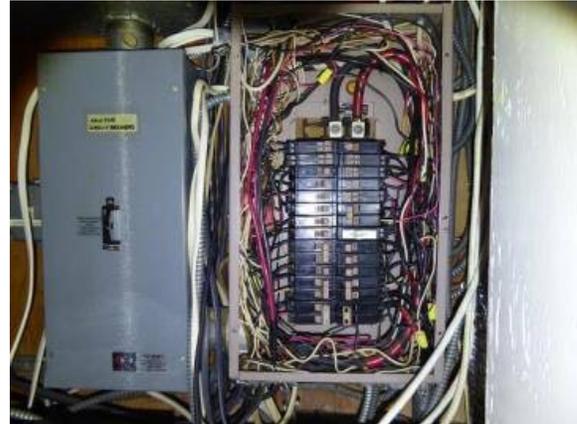
This panel has the neutral (white) wires and the ground (bare copper) bonded to the same bus. The neutral is only bonded to ground at the service equipment which is the disconnect located next to the panel. At all other points throughout the house, there should be no connection between the bare (or green) grounding conductor and the white neutral conductor. Under normal conditions, the grounding conductor carries no current. No current means there is no voltage drop along it, therefore anything "grounded" to this conductor is at the same potential (voltage) as ground. If the neutral and ground are bonded at the sub panel, then stray currents from the neutral return could go thru the equipment ground on the electrical devices fed from this sub panel. The service equipment panel is where the neutral and equipment ground should be bonded and services of a qualified electrician are needed to correct the wiring in this panel.

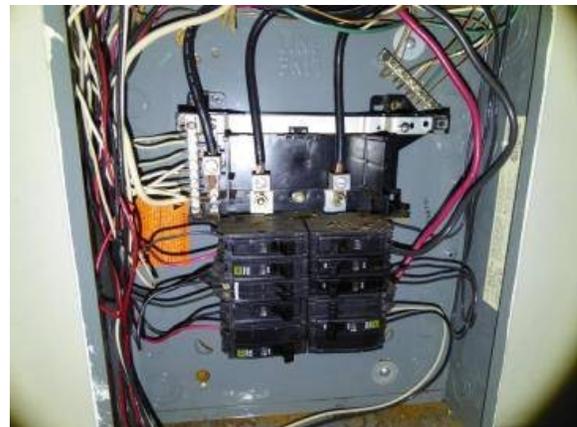
Further Evaluation: The sub-panel has the neutral (white) wires and the ground (bare copper) bonded to the same bus. The neutral is only bonded to ground at the service panel. At all other points throughout the house there should be no connection between the bare (or green) grounding conductor and the white neutral conductor. Under normal conditions, the grounding conductor carries no current. No current means there is no voltage drop along it, therefore anything "grounded" to this conductor is at the same potential (voltage) as ground. If you bond the neutral and ground at the sub panel, then stray currents from the neutral return could go through the equipment ground on the electrical devices fed from this sub panel. The main panel is where the neutral and equipment ground should be bonded and services of a qualified electrician are needed to correct the wiring in this panel.

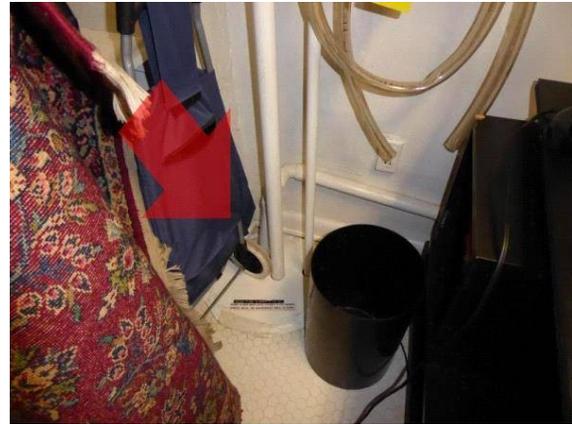
Satisfactory: The sump pump installed is functional. The pump was tested by operating the float switch. The presence of a sump pump does not indicate there is a need for it. This inspection does not verify the existence of or effectiveness of any subslab or perimeter drainage system. It appears that the sump crock is the only collection point . The crock is made of a perforated plastic bucket and there is no drain tile piping visible. Recommended Upgrade: Power outages are not unusual and pumps can fail to operate at anytime. A reliable back-up is needed. We recommend you install a battery backup system. Once installed these units do need periodic service and/or battery replacement. They must be maintained to be relied upon. Sump pumps are installed by plumbers and foundation drainage contractors.

Sump pump at left side

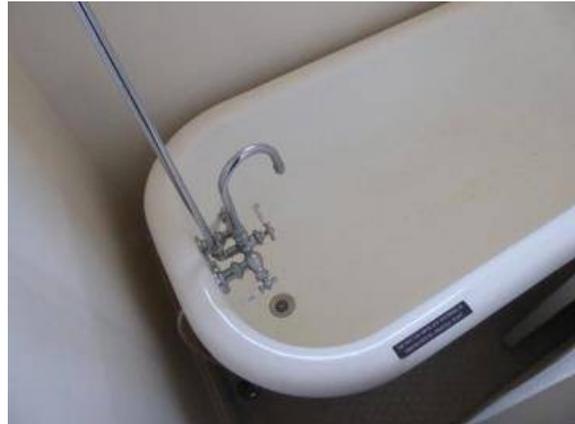
The tub water supply was not evaluated. A sign from the property management states do not use.
