# VILLAGE OF FRIENDSHIP HEIGHTS INFRASTRUCTURE ASSESSMENT

AMT File No. 22-0124.001

**A. Morton Thomas and Associates, Inc.**

**August 2, 2022**

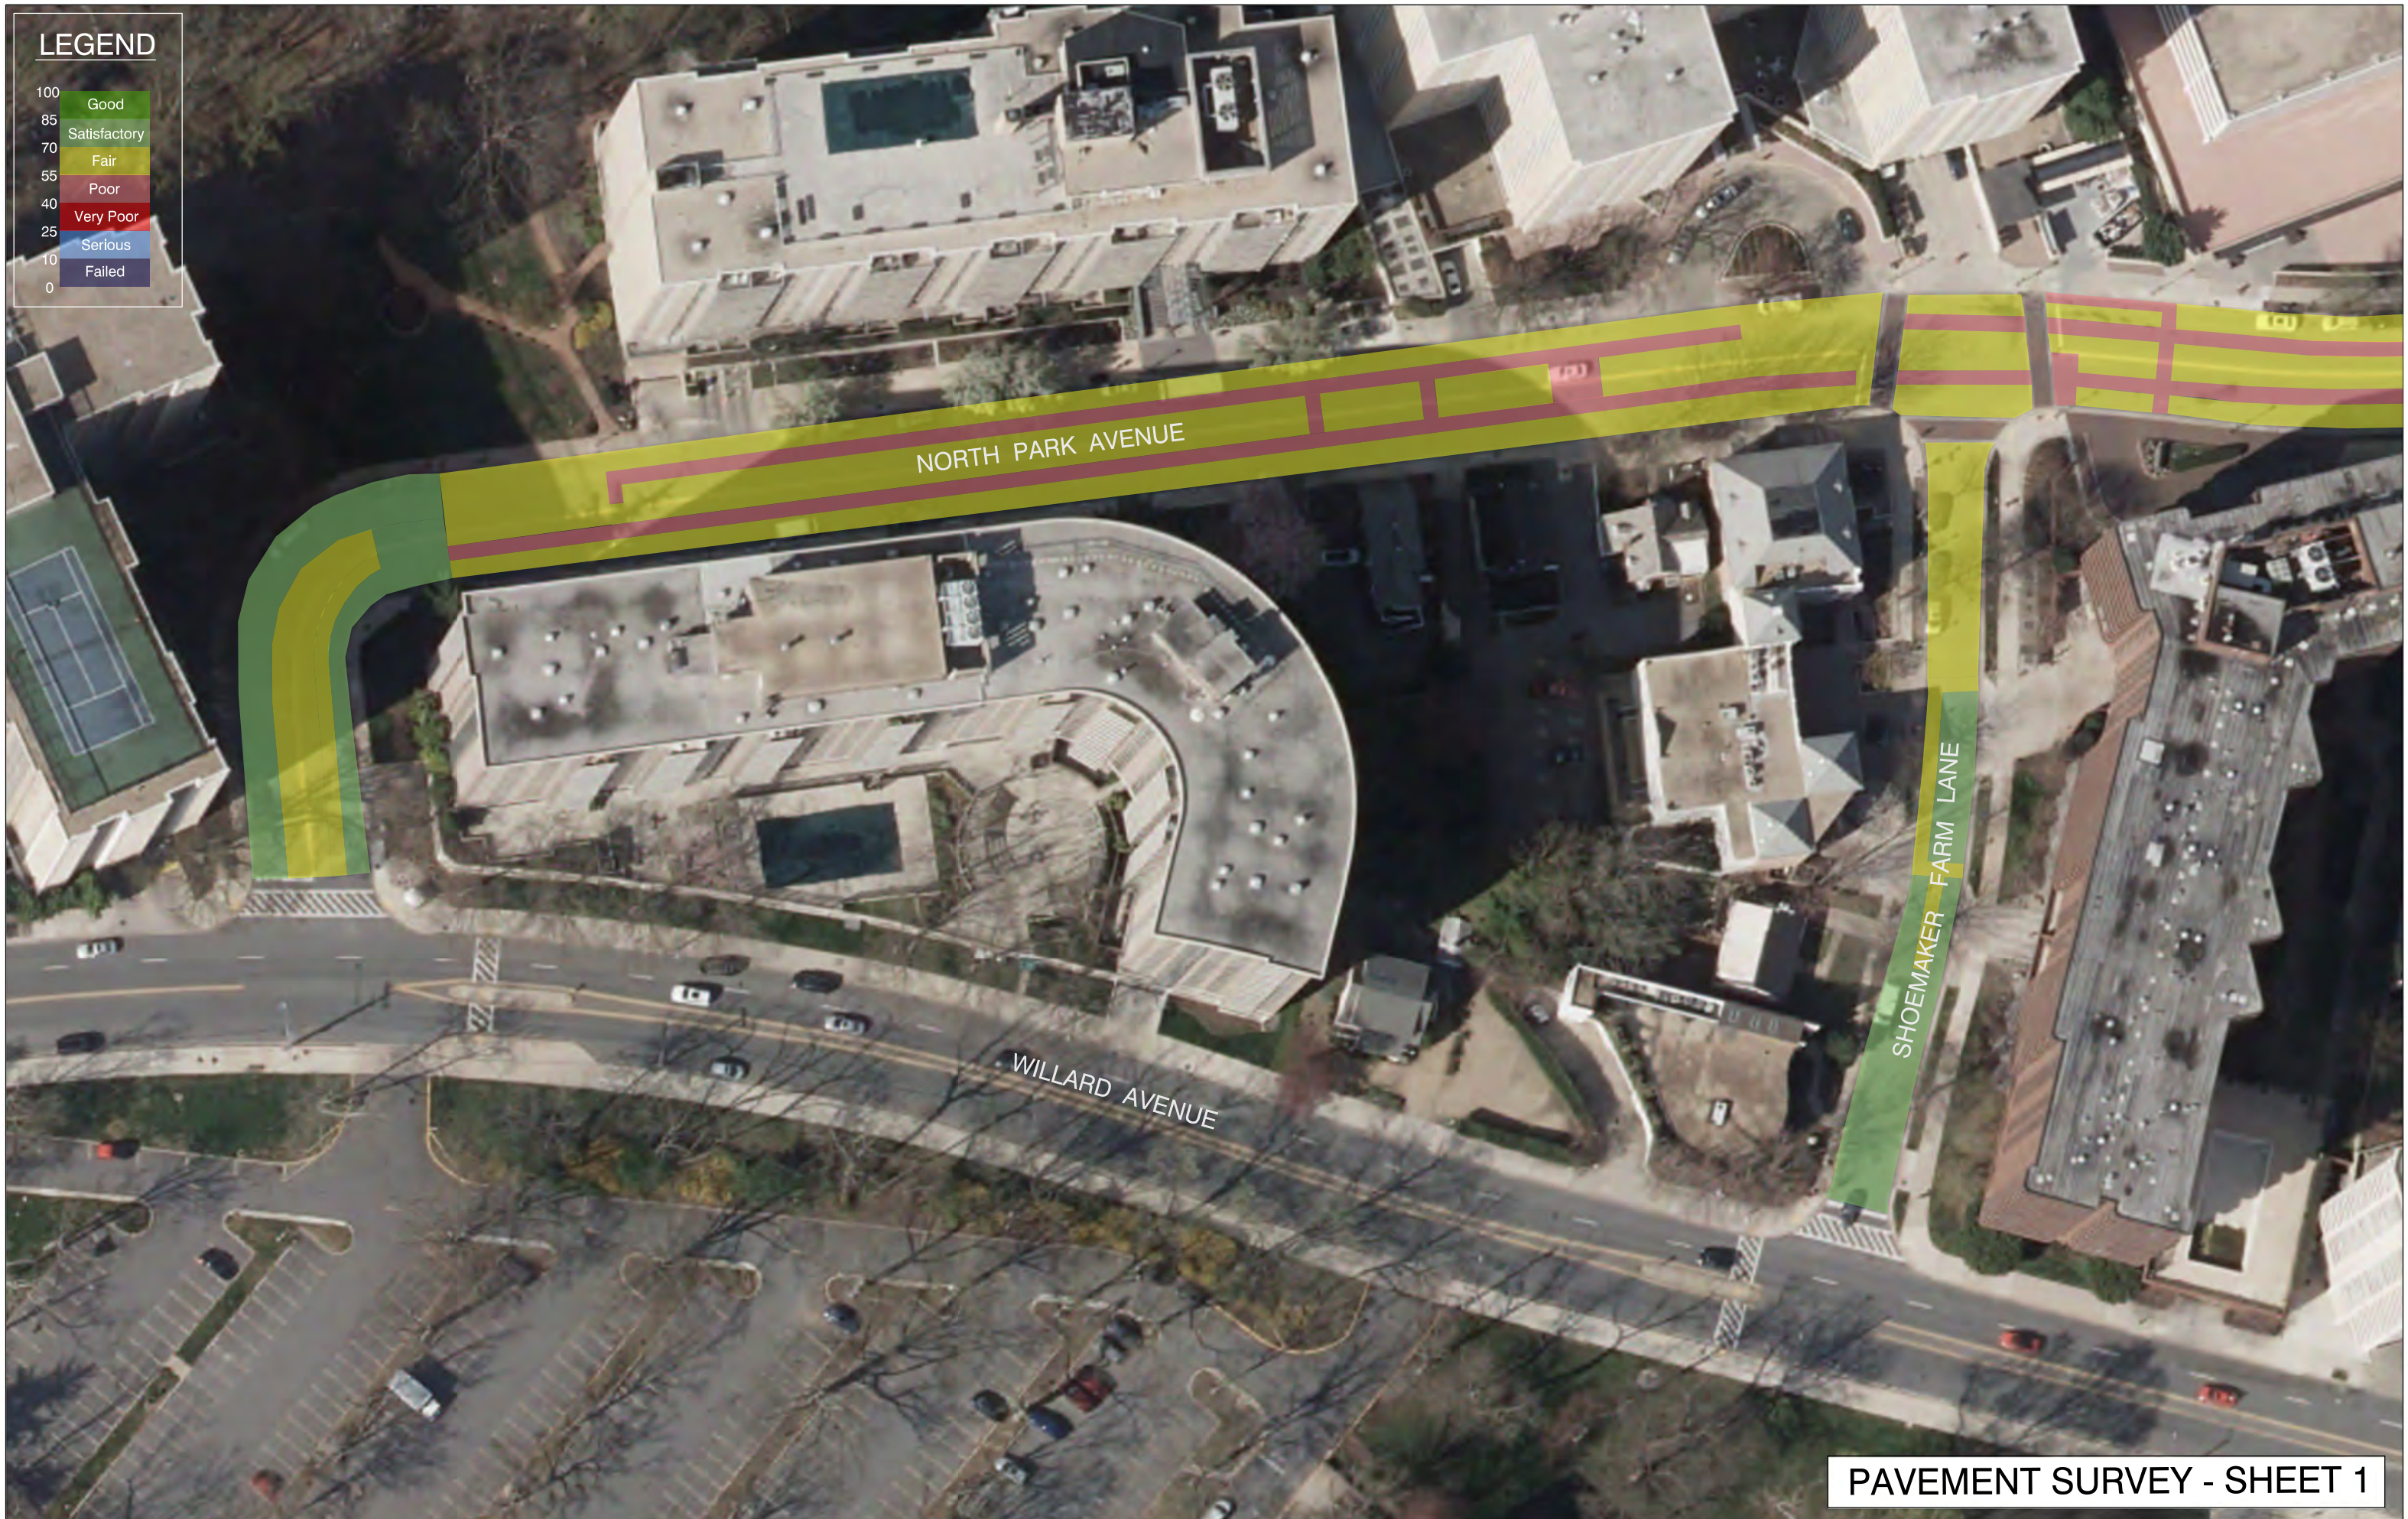
1.	North Park Avenue	Willard Avenue to Shoemaker Farm Lane	X	X			<b>Fair-Poor</b>	Portion connecting to Willard Avenue in satisfactory condition.
2.	North Park Avenue	Shoemaker Farm Lane to Friendship Boulevard	X	X			<b>Fair</b>	50% in good condition (eastern portion) 50% in fair-poor condition (western portion).

3.	Shoemaker Farm Lane	Willard Avenue to North Park Avenue					<b>Satisfactory</b>	Northern portion in fair condition/Southern portion in satisfactory condition.
